Facts and Findings from the Accident

Charting Aspects of the Volvo Ocean Race Stranding

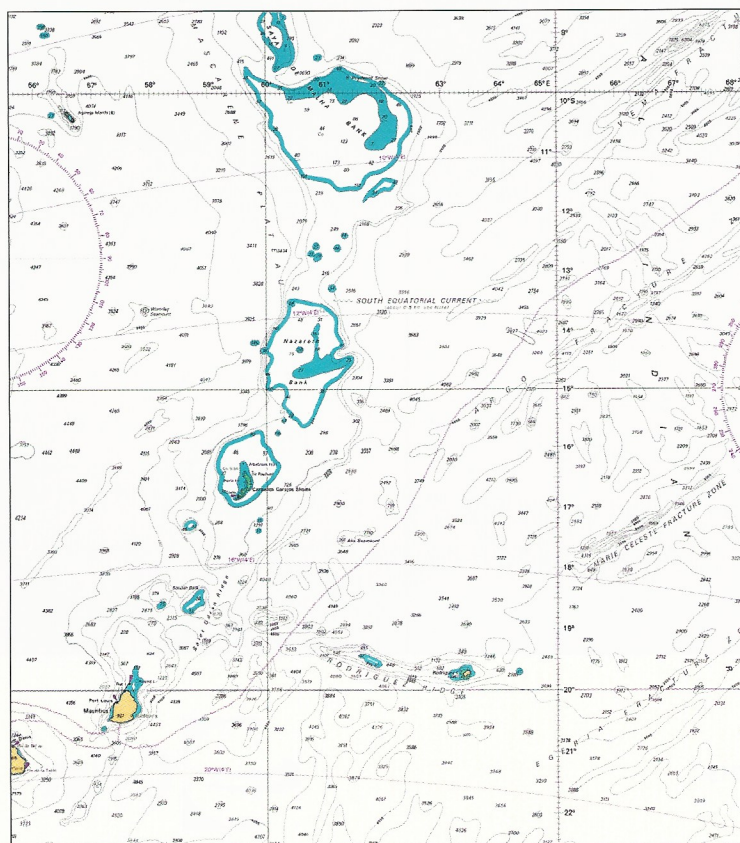
- The shoals are also clearly indicated as a drying feature on two small-scale (planning and overview) paper charts. BA4072, covers the whole of Leg 2. BA4702 (Figure 1) includes the critical section of the shoals northward from Mauritius and covers the Chagos Archipelago to the east.

▲ Figure 1: Paper chart BA4702, which includes the critical section of the shoals northward from Mauritius and covers the Chagos Archipelago to the east.

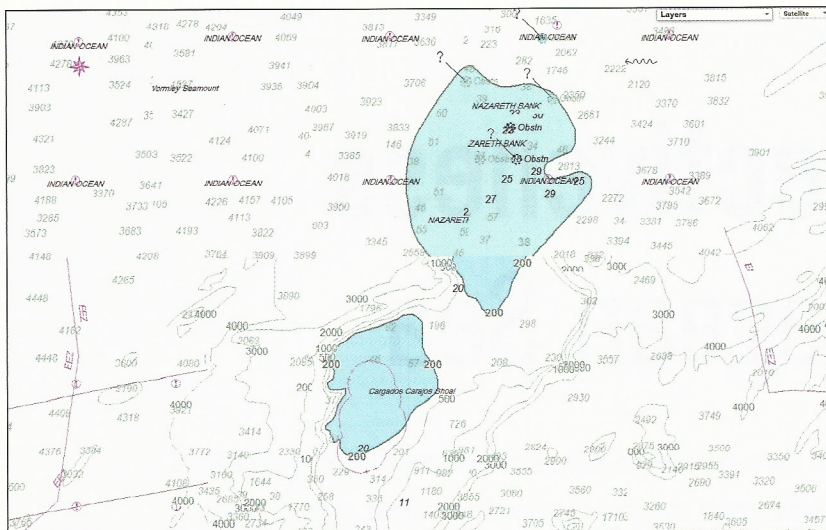
- At the zoom level interrogated by the navigator, the Cargados Carajos Shoals (Figure 2) are named and indicated by a blue shaded area bounded by the 200m isobath with spot depths from 20 to 82m. The navigator stated that the planned track passing over the shoal area was based on the least depth being 40m.
- Navionics rectified the chart in between times. There has been no reaction from C-Map.
- In the video of the grounding one of the crew reports a sounding of 40m just before the hit. Probably too late to take evasive action at 19 kts; but none appeared to have been attempted.
- The 6 other race participants managed to steer clear of danger; but leading boats would also have done so in daylight. Several reported that the true nature of the shoal was only apparent at much higher zoom levels than was usually required for passage navigation.

▲ Figure 2: The Cargados Carajos Shoals at the zoom level interrogated by the Vestas Wind navigator.
